**DEPARTMENT OF TRANSPORTATION****DIVISION OF ENGINEERING SERVICES**

Office of Structural Materials

Contract #: 04-0120F4Cty: SF/Ala Rte: 80 PM: 13.2/13.9File #: 69.28**WELDING INSPECTION REPORT****Resident Engineer:** Siegenthaler, Peter**Address:** 333 Burma Road**City:** Oakland, CA 94607**Report No:** WIR-016943**Date Inspected:** 14-Sep-2010**Project Name:** SAS Superstructure**OSM Arrival Time:** 1900**Prime Contractor:** American Bridge/Fluor Enterprises, a JV**OSM Departure Time:** 700**Contractor:** Zhenhua Port Machinery Company, Ltd (ZPMC), Changxing Island **Location:** Shanghai, China**CWI Name:** See below**CWI Present:** Yes No**Inspected CWI report:** Yes No N/A**Rod Oven in Use:** Yes No N/A**Electrode to specification:** Yes No N/A**Weld Procedures Followed:** Yes No N/A**Qualified Welders:** Yes No N/A**Verified Joint Fit-up:** Yes No N/A**Approved Drawings:** Yes No N/A**Approved WPS:** Yes No N/A**Delayed / Cancelled:** Yes No N/A**Bridge No:** 34-0006**Component:** Tower and OBG Components**Summary of Items Observed:**

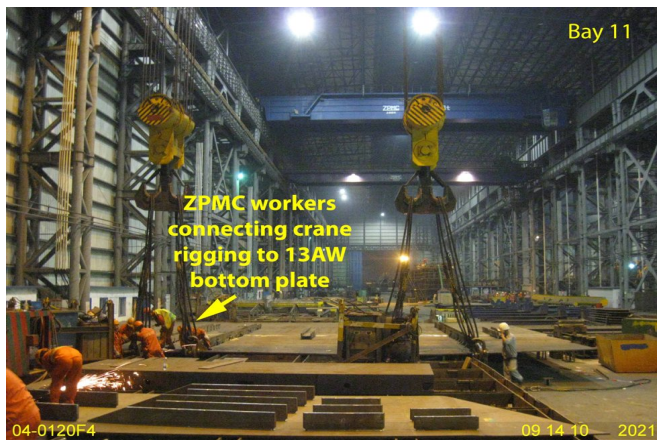
FCAW welding of temporary stiffener beams to side A of PCMK OBG segment 13AW, bottom plate. Welders were identified as 202122, 047866. QC was identified as QC1. Assisting QC1 at this location and appearing to be monitoring the welding and recording data was QCA1, who was not a CWI. Welding variables were not recorded by QCA1. Upon limited observation, the weld joints did not appear, to this QA Inspector, to be at or above the minimum preheat and interpass temperature. QCA1 assured this QA Inspector that he was checking the preheat and interpass temperatures and they were always within tolerances of WPS-B-T-2132. A 200T+200T overhead crane was rigged to one end of the bottom plate, but also upon limited observation, this QA Inspector did not observe any lifting of the bottom plate. See photo below.
